BUREAU OF SHIPS GROUP TECHNICAL INSPECTION REPORT

6 OPERATION CROSSROADS.
U.S.S. MUSTIN (DD413)

TEST ABLE [U].

USS MUSTIN (DD413)

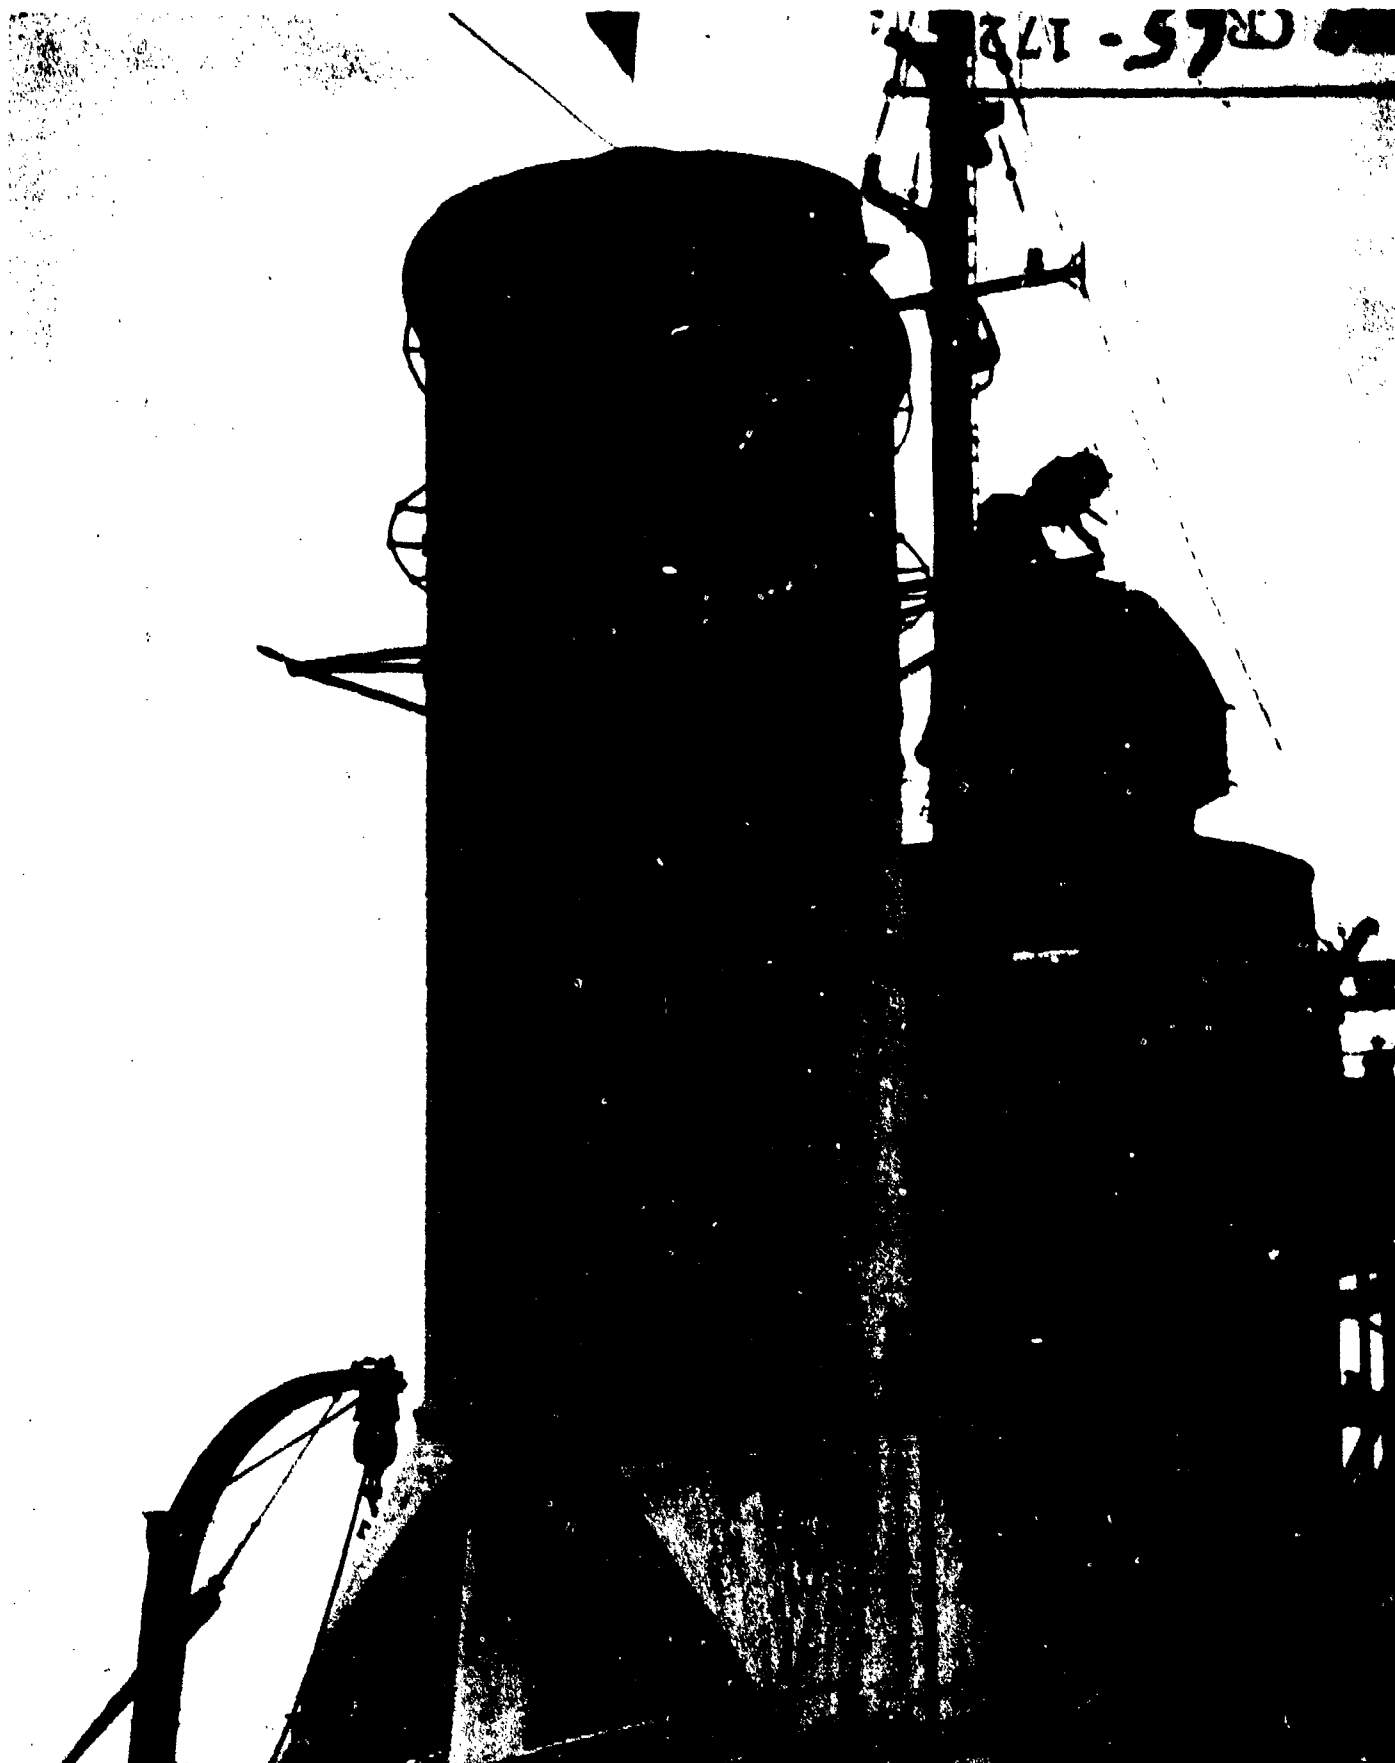
The after side of both port and starboard flag bags is dished to a depth of one inch. (Photo 1728-6, page 31).

AA-CR-65-1728-6. Looking forward to superstructure showing damaged paint on stack.
